| City of Baltimore Wet Smoke and Dyed | Page 1 of 2 | |
| Sewershed: Gwynns Falls | Company: Savin | Date: 4/22/2009 |
| Manhole_ID: S04EE1013MH | Test ID: <u>D1032-028010</u> | Notification Made: NA (Residents, Fire, 311) |

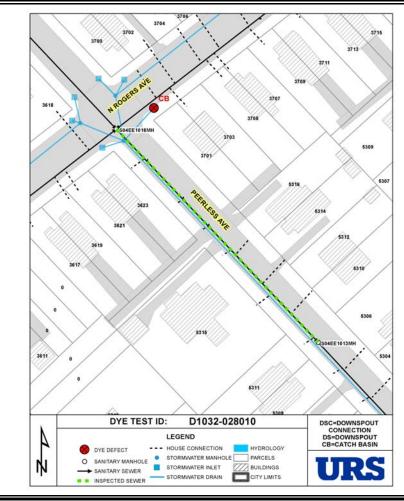
Field Sketch: Show all manholes with Numbers, Blower Placement Locations, Sandbag or Isolation Locations, Street Names, Building Addresses and Locations, Defect Locations and Photo Numbers.
